FINAL REPORT  
ON THE COLLISION BETWEEN A  
CARGOLUX OPERATED BOEING 747-400F  
REGISTERED LX-OCV  
AND A MAINTENANCE VAN  
ON RUNWAY 24  
AT LUXEMBOURG AIRPORT (ELLX)  
ON 21 JANUARY 2010, 11:53 UTC

DATE OF ISSUE : 10 DECEMBER 2012

**Report N° AET-2012/AC-01**

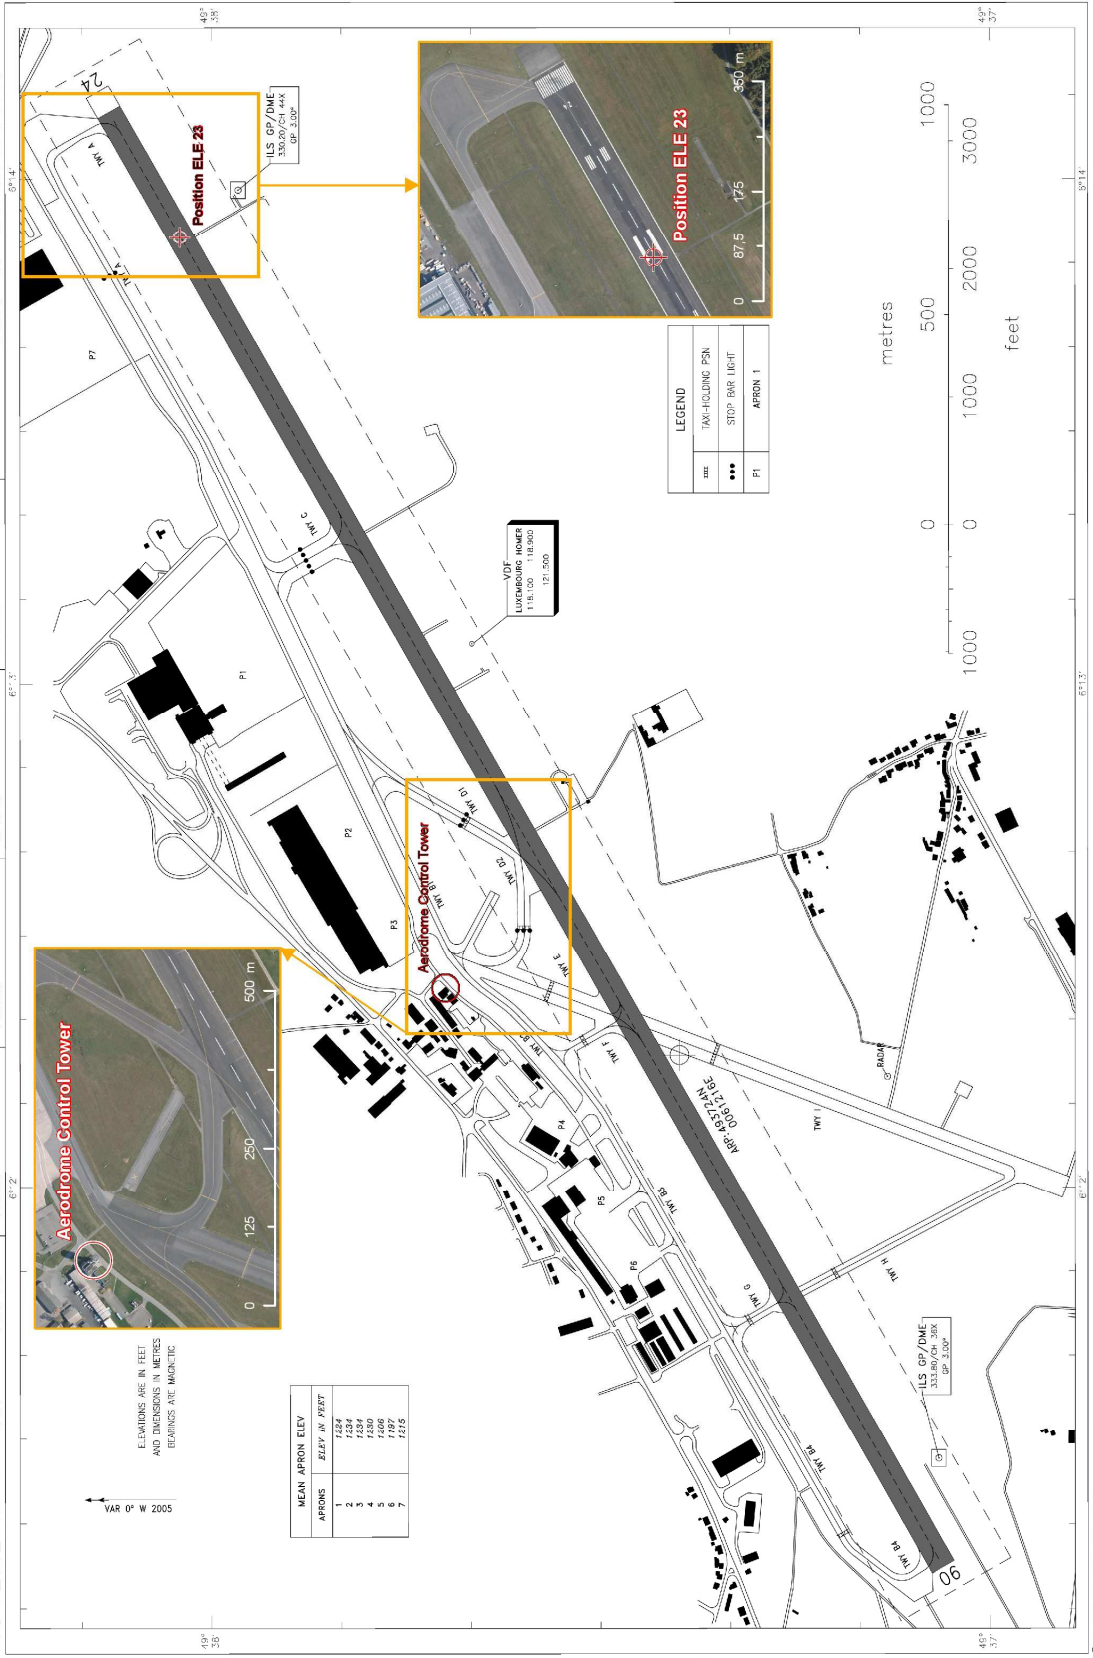
Figure 1: Aerodrome Ground Movement Chart (Source AIP Belgocontrol, ACT, AET)

The airport chart from the AIP is shown hereafter. The aerodrome control tower and the position of ELE 23 at the time of the occurrence are highlighted on the chart.

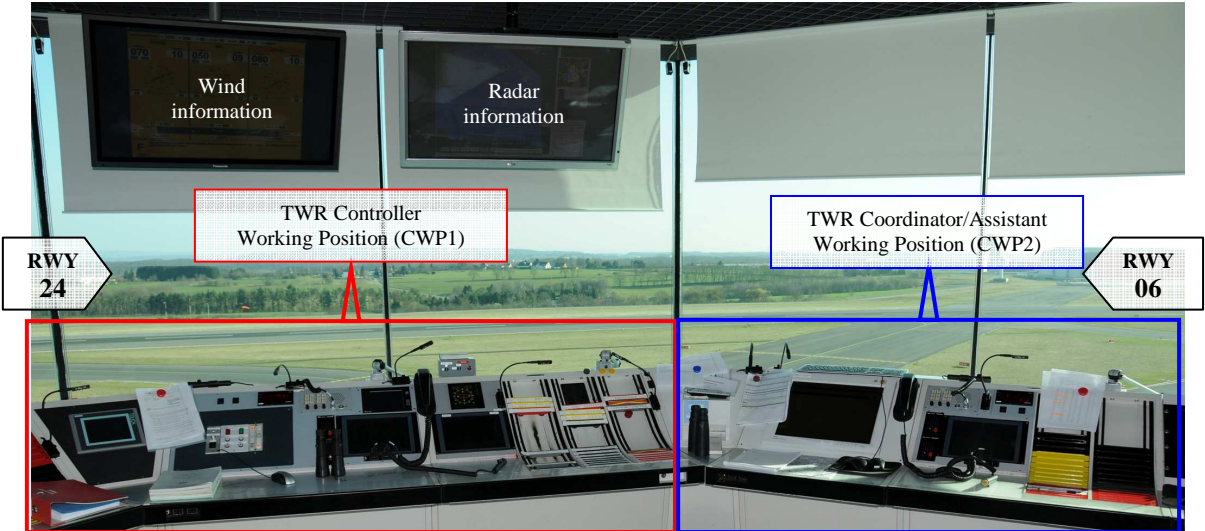
Picture 4: Tower Layout (Source AET)

The TWR controller working position (CWP1), in addition to the control console equipment, has two screens located above the working position. One screen is displaying the information from primary and secondary approach radar on a background image depicting the Luxembourg CTR and TMA. The other screen is providing wind information for the runway in use. The TWR control observation point is situated at a height of approximately 32 m above ground.
